LAND-TECH CONSULTANTS, INC.

July 11, 2002

Re: Truesdale Lake Dam Safety

At your request, Land-Tech Consultants, Inc. has completed a preliminary evaluation of the safety of the dam forming the Truesdale Lake impoundment, hereinafter "the Dam."

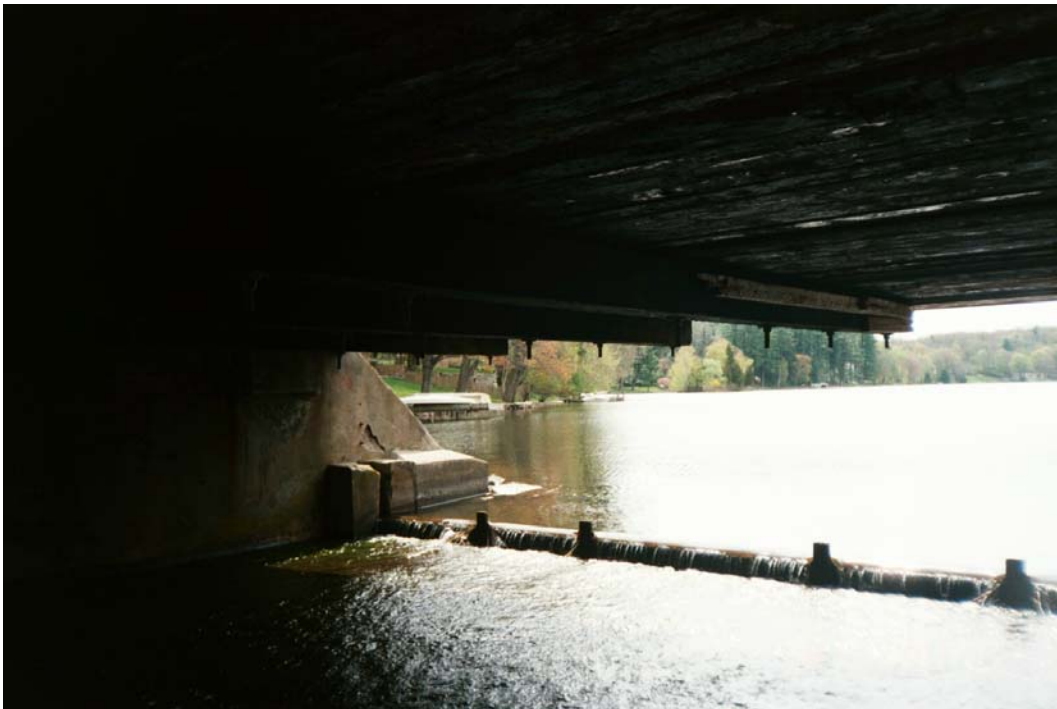
The primary spillway is a 19.75-foot wide concrete chute with concrete blocks cast into the spillway to allow for insertion of weir boards to control the upper 1.5 feet of the lake level. The concrete blocks reduce the spillway width to 17.75. At the time of inspection (April 20, 2002) one six-inch weir board was in place.

Photo 4: Spillway & Underside Of Bridge Deck, Looking Upstream (Note- Single Weir Board In Place).

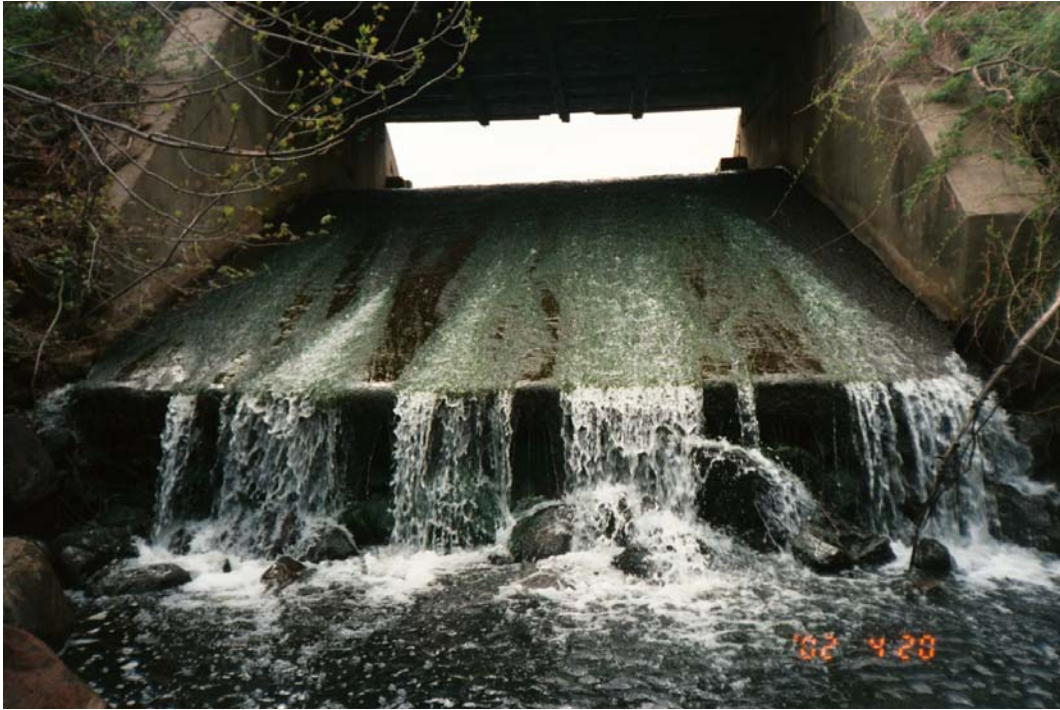
Photo 5: Downstream Face Of Spillway.

The downstream face of the spillway chute is unmortared masonry with voids that are up to three feet deep (photo 5). Immediately downstream of the spillway chute is an unlined plunge pool.

7. Line the existing plunge pool at the primary spillway outlet with "standard" size riprap (typically 18-24 inch stone). This will serve to buttress the existing dry

- masonry wall and reduce the probability of undermining when large discharges occur. It will also protect the erodible banks of the existing pool
8. Investigate the three-foot by three-foot concrete box on the downstream side of the road. If it is a gate it should either be repaired or grouted shut. It is not advisable to have a gate located downstream of the centerline of a dam, because such a condition allows a pressurized pipe to extend through the dam. Leakage from deterioration or a break in the pipe would cause failure of the dam.
 9. Develop and put into practice a routine operation and maintenance plan including an annual visual inspection.

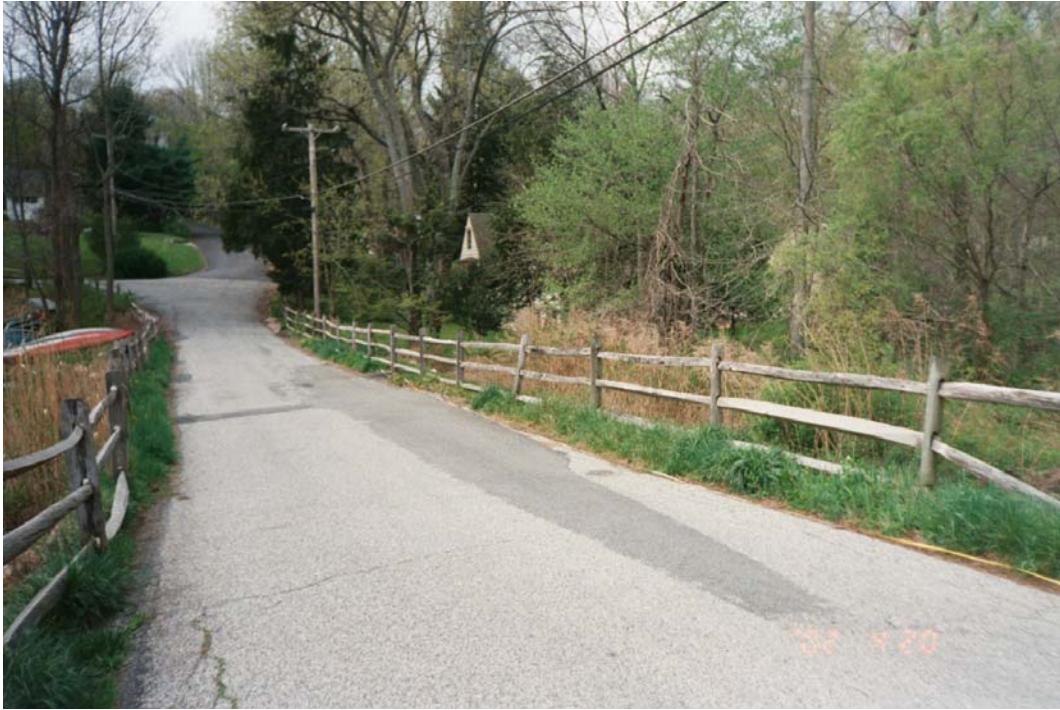
Photo 7: Looking West To Area Of Washout.

A downstream portion of the emergency spillway was reportedly washed out and repaired within the last three to four years (photo 12). Based on a depressed pavement area and longitudinal cracks (photos 7 & 13), the repaired area appears to be experiencing ongoing settlement of the fill material.

4. During work on the downstream slope, excavate and recompact the fill material in the vicinity of the previously repaired washout.
5. Remove stumps and any roots over one inch in diameter from the upstream slope of the dam. The resulting void should be backfilled with a well-compacted silty gravel, and the area should be planted with grass.

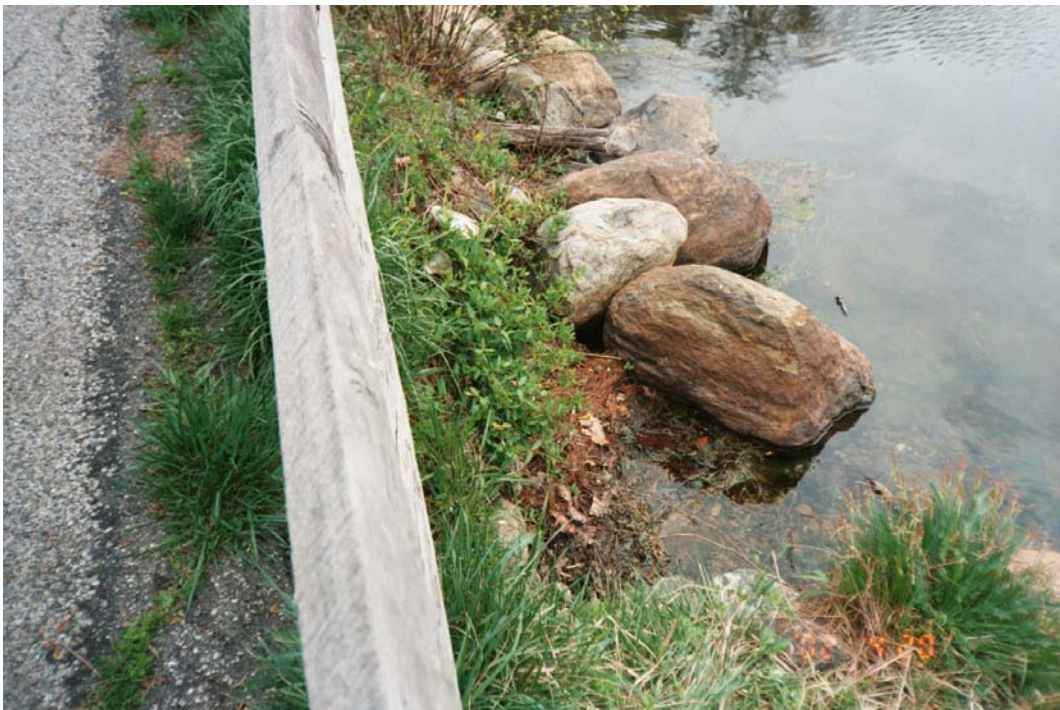
The upstream area of the dam has an average slope of 2.5H:1V above the water line. The slope is covered by sparse riprap that has been displaced by wave action and pedestrian traffic. At several locations there is a six to twelve-inch nearly vertical drop at normal lake level, due to wave action. No animal borrows were observed. At several locations

Photo 8: Riprap Along Shore.

6. Smooth and regrade the upstream slope, and then replace riprap on the reconstructed slope of the dam. The riprap should extend a minimum of two feet below the normal lake level.

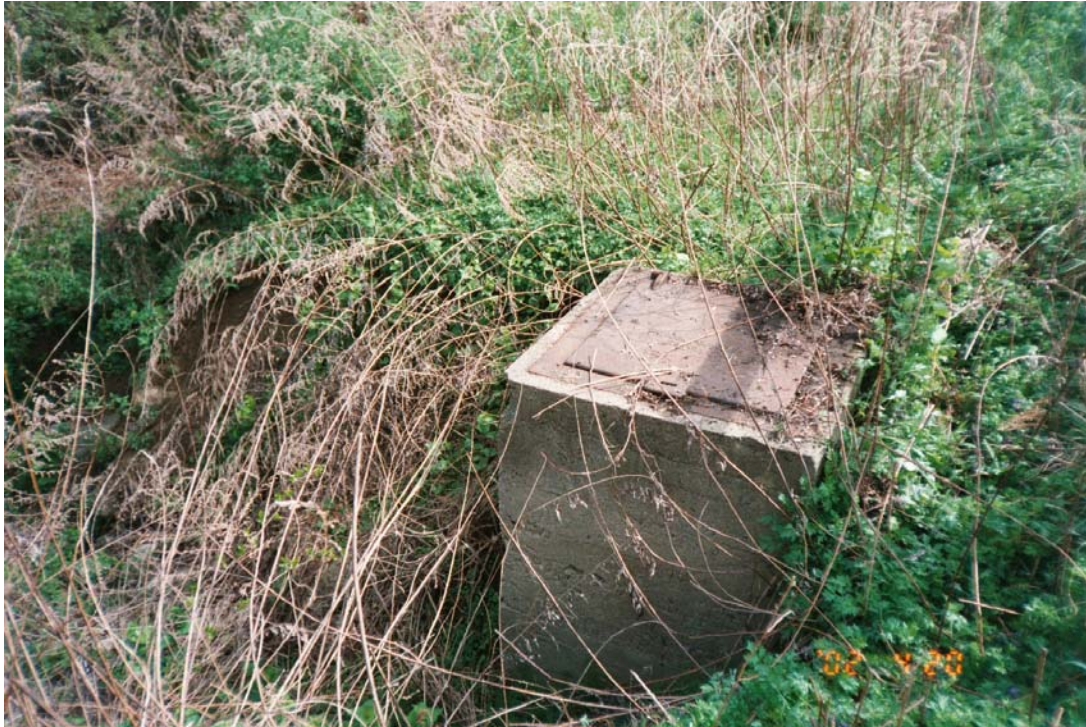
Photo 11: Concrete Box (Possible Gate Chamber ?).

No apparent outlet appurtenances were observed. The three-foot by three-foot concrete box on the downstream slope and the corresponding concrete wall on the upstream slope may be parts of an outlet works. A 1993 inspection report by NYDEC indicated that a low level outlet had not been operated for at least eight years. At the time of the inspection (April 20, 2002) a metal plate on top of the concrete box was locked and the area lakeside of the wall was filled with debris and silt.

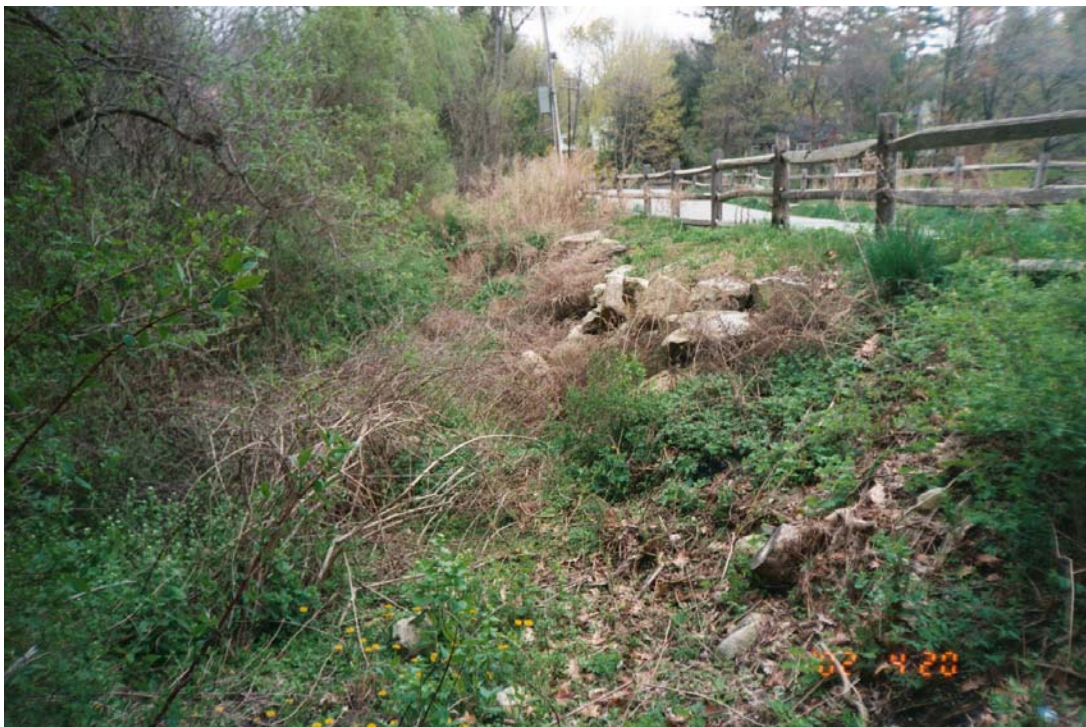
Photo 12: Downstream Face Of Dam In Area Of Washout.

The downstream slope of the Dam varies considerably. In the vicinity of the washout area, there is a three-to-four-foot-high, almost vertical, masonry face (photo 12). In the areas adjacent to the spillway, the slope is about 2H:1V. At approximately 215 feet from the right abutment, there is a three-foot by three-foot concrete box. Immediately adjacent to the box, there is a two-to-three-foot-deep erosion gully. At both abutment contact areas, there are erosion paths caused by discharge from storm (road) drainage pipes.

1. Protect the road from erosion so that it can continue to be used as the emergency spillway. This will involve armoring the slopes, especially the downstream slope.

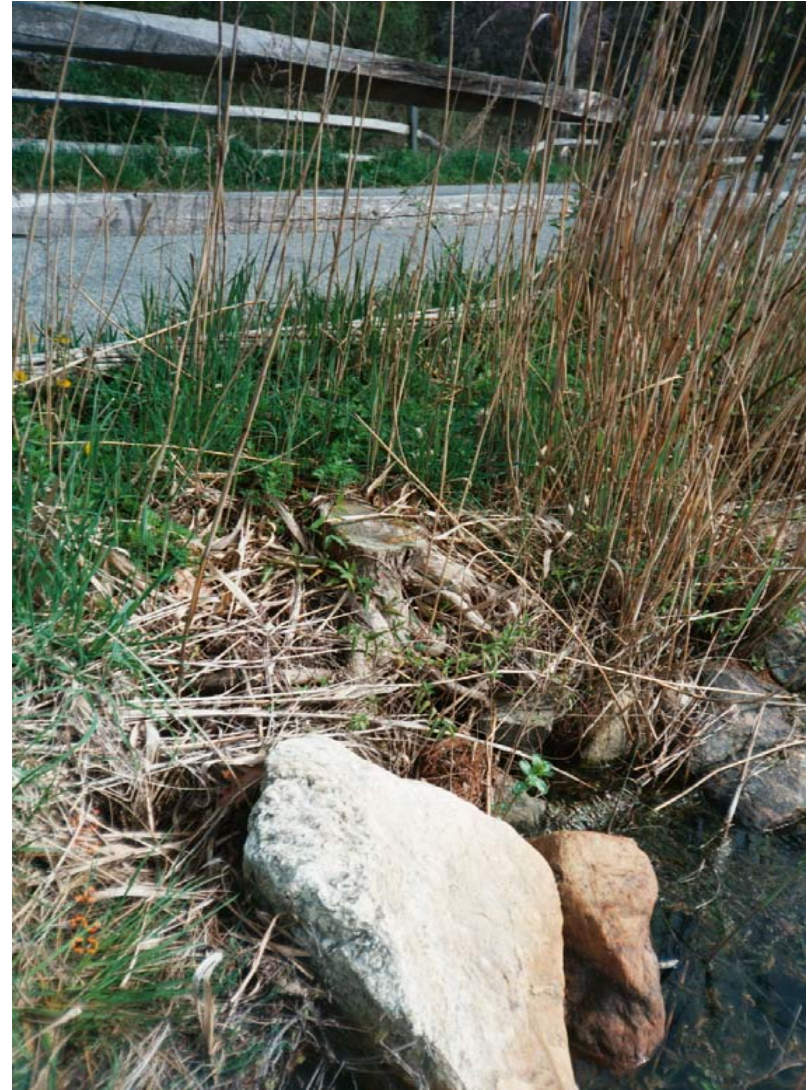
Photo 14: Tree Stumps On Upstream Face.

concentrated road runoff has created minor erosion channels. The remains of several tree stumps were observed (photo 14). At approximately 210 feet from the right abutment, a four-foot-long by one-foot-thick concrete wall was observed.
