**TRUESDALE LAKE PROPERTY OWNERS ASSOCIATION
SOUTH SALEM, NY**

**2005 AQUATIC PLANT
MANAGEMENT PLAN
TRUESDALE LAKE**

ALLIED BIOLOGICAL, INC.
580 Rockport Road
Hackettstown, NJ 07840
(908) 850-0303

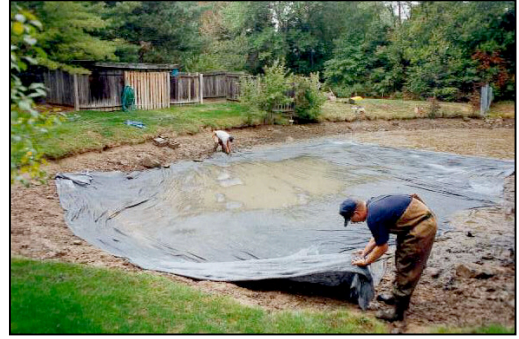
Benthic Barriers: A benthic barrier is a synthetic or organic sheet (i.e. Aquascreen®, Texel®) that is placed over the lake bottom to create a growth inhibiting barrier. This method is very effective in small areas (less than 1 acre), and thus is suitable for high use areas such as boat launches, beaches, or property fronts. Multi-year control is possible, if the barrier is properly maintained season to season. Benthic barriers have been effectively used at Lake George (Lyman and Eichler, 2005)

and Ellis Pond, Dutchess County (Allied Biological). However, benthic barriers are expensive, labor intensive to install, and must be maintained. Over time, sediments will become deposited on top of the barrier, and if not removed, these sediments can actually become colonized by some aquatic plant species. In addition, sediments below the barrier can release gasses that will cause the barrier to billow up. If the barrier is constructed of an impermeable material, these gasses need to be relieved periodically, a process called “burping”. Benthic macro-invertebrate communities are negatively impacted by the addition of a benthic barrier. Barriers are also non-selective in the types of plant species controlled.

Installation of benthic barriers is easier if the lake is drawn down, but in-water installation is possible. Many different anchoring techniques can be used, although Allied Biological has had success with weighing down the entire perimeter of the barrier. Ice installation entails laying the barrier on top of a frozen area. As the ice melts, the barrier sinks into place. This last method is not recommended. Most non-professional installations of benthic barriers are performed with cheaper, impermeable PVC materials (available at landscape supply stores), using this installation technique.

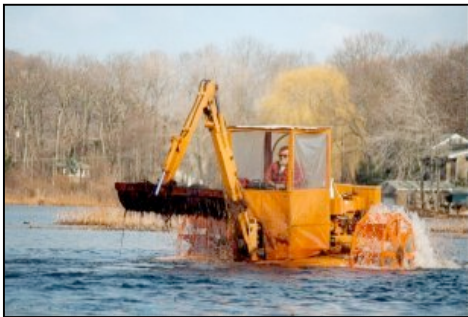
Mechanical Raking: Mechanical raking, also called hydroraking, consists of a specialized paddle wheel propelled barge with a york rake mounted on a backhoe arm. The rake is lowered into the lake sediment, and pulled until full (usually about 0.5 cubic yards). The material is then placed on shore for dewatering, and eventual disposal. Although a slow process, this method does provide multi-year control since most of the plant is removed, not simply cut as

in mechanical harvesting. Hydroraking is much more efficient at removing water lily and emergent plants, due to the root structures. Submersed aquatic plant root systems tend to be smaller and more delicate, and therefore not removed by the rake. Costs are significantly higher than mechanical harvesting due to the slow pace of the work, and a disposal site is needed for the removed material. The SmokeRise Club (Lake Kinnelon, NJ) has successfully utilized hydroraking the past few years to create open water in previously inaccessible coves. 120 hours of hydroraking was conducted in 2003, resulting in the removal of approximately 1,675 cubic feet of material, at a cost of \$21,900.

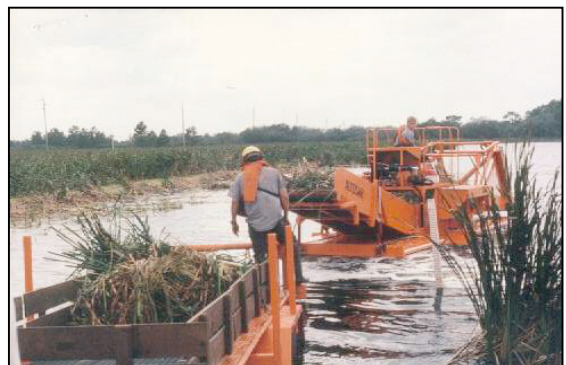
Mechanical Harvesting: This method involves the mechanical cutting of aquatic plants with specialized boats equipped with cutting bars. Most operations include the removal of the clippings as well, either by another vessel or by the harvester itself. If performed by experienced individuals, this method can be quick and efficient. It is useful

in areas near launches and efforts to maintain open water channels through “topped out” aquatic vegetation beds. However, it’s a short term solution at best, as root structures are not removed. Areas often need to be harvested multiple times per season to achieve desired control. Harvesting is non-selective, and includes a significant by-catch of aquatic and semi-aquatic macro-invertebrates, and forage fish. Harvesting activities can even increase the spread and density of aquatic plants that reproduce via fragmentation, such as Eurasian water milfoil, and fanwort. A suitable off-site disposal site is needed for the clippings. In the past, it was claimed that the removal of plant biomass reduced the amount nutrients in the lake system. However, numerous ecosystem studies, such as Lake Wingra in Wisconsin, concluded the removal of this plant biomass did not significantly remove nitrogen and phosphorous to offset the internal pools of those nutrients (Carpenter and Adams, 1978).

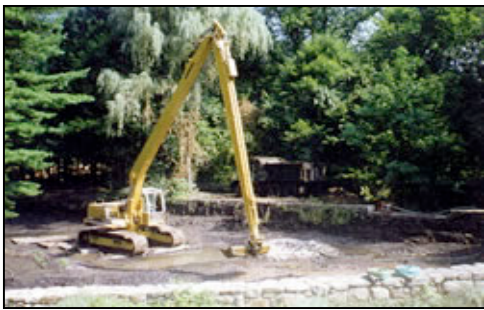
Dredging: This method is usually not solely used for aquatic plant control. Dredging is employed to deepen water that has been filled in from sedimentation (often sped up by man-made activities), remove excessive nutrients, or even remove toxic substances in the sediments. As a side benefit of these lake restoration projects, deeper water and nutrient removal often limits aquatic plant growth. Although long-term aquatic plant

management control can be achieved (sometimes as long as a decade), the method is non-selective, and creates numerous environmental impacts. This method is very costly, and often the costs increase if the dredged material needs to be trucked off-site for disposal.

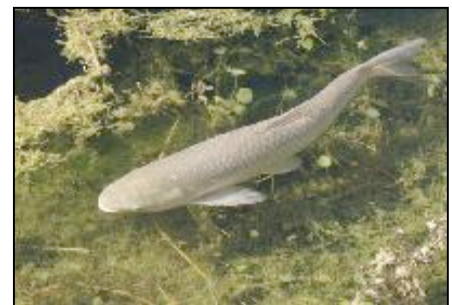
Grass Carp: The most widely used biological control of aquatic plants is grass carp (*Ctenopharyngodon idella*), a non-native herbivore. Although a permit is required, grass carp are easy to implement into a lake system, and relatively inexpensive, once stocking costs are spread over several years. Results are slow, but multi-year control can be obtained. Grass carp are selective feeders, often feeding on preferred plant species until eradicated before moving on to less desirable species. For example, grass carp will only graze on Eurasian water milfoil and floating plants (such as lilies) as a last resort, removing all native (usually desirable) plants first. This selective grazing can have negative impacts on game fish populations, as suitable habitat for juveniles is removed. Second, in a large lake, the grass carp tend to establish feeding patterns in preferred locations. This location might not be consistent with areas the

Association wishes to be controlled. Barriers or other structures need to be constructed to prevent the fish from escaping the lake. Finally, grass carp grazing on aquatic plants tend to disturb the bottom sediments, which reduces water clarity and adds nutrients (once bound to the sediment) back into the water column. These two factors can cause a shift from an aquatic plant dominated community to an algal dominated community.
